Economic Impact of Corrosion and the Effect of Surface Decontamination on Coating and Asset Durability

New Technology Advances Highly Effective Corrosion Control

September 2016

Scanning Electron Microscope & Energy Dispersive X-Ray Spectrometer Analysis of Samples Cleaned with CleanWirx

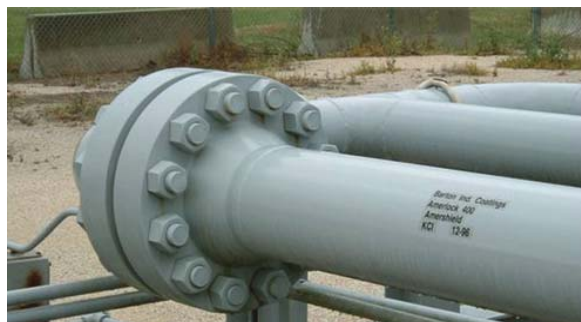
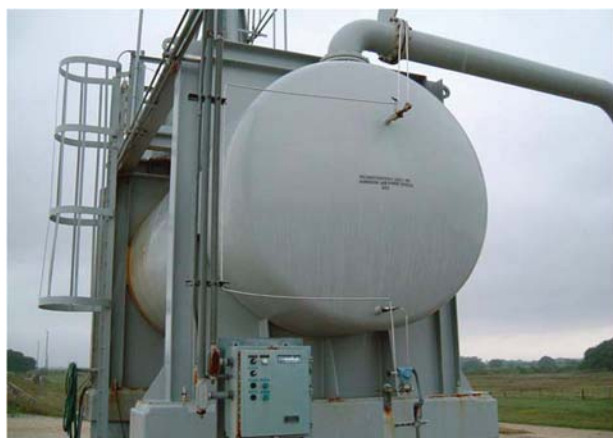
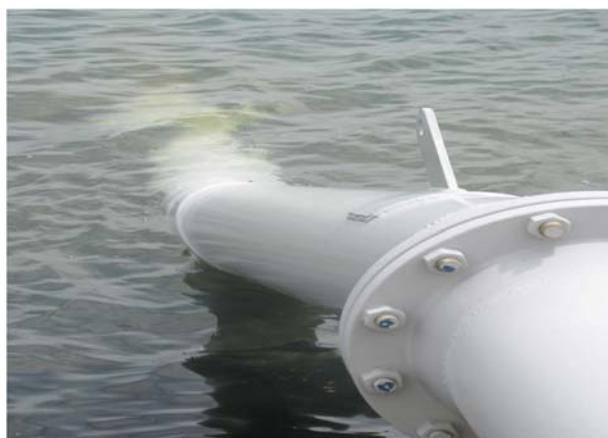
Image 1, 2, & 3: 12" pipe and drums (located adjacent to four brine pits) were treated with CleanWirx, and coated with standard epoxy coating. Equipstar storage facility maintenance project conducted in October 1995 has enjoyed over ten years of maintenance-free durability. This photograph was taken in October 2005. Project demonstrated no corrosion and no coating deterioration. Source: CleanWirx (2006).

CHALLENGE: Aggressive corrosion on 12" pipe and drums adjacent to four brine pits going into water with a salt concentration of 300,000 parts per million.

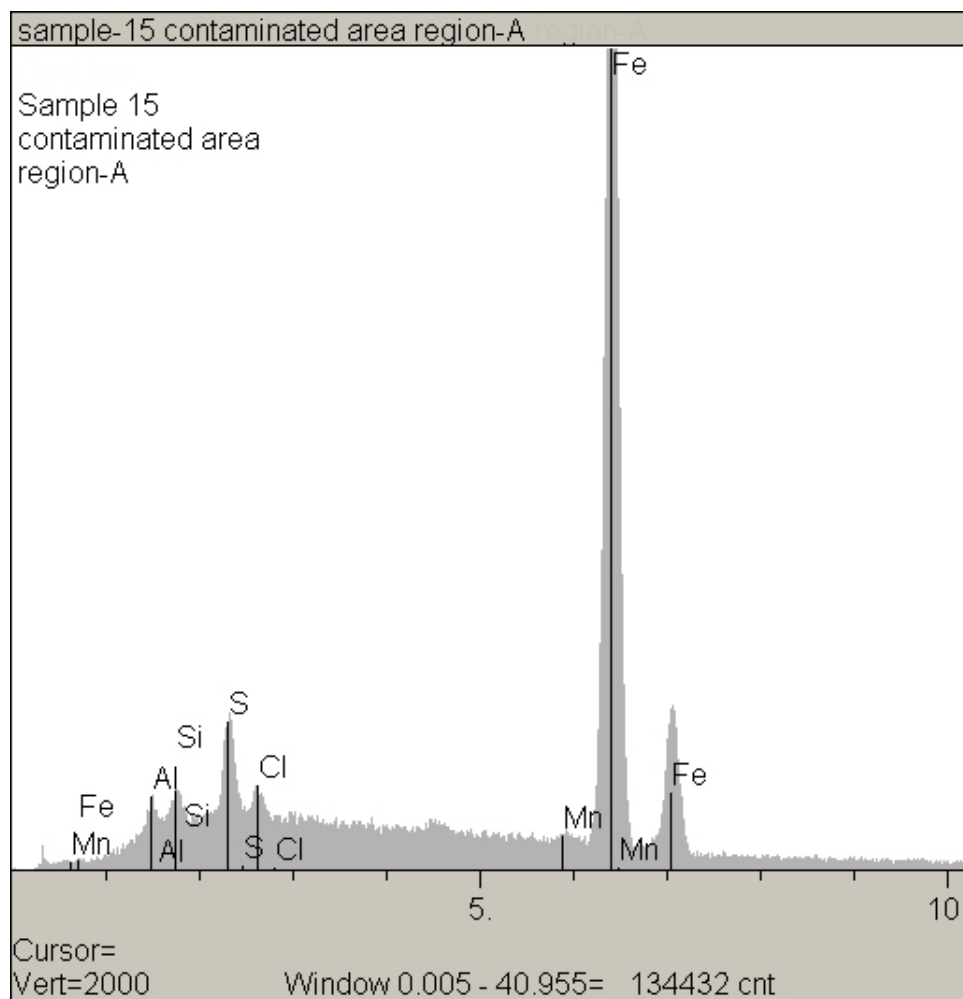
Sample #2 – EDS Report, Field A, Region A:

Elt.	Line	Intensity (c/s)	Error 2-sig	Conc	Units	
Al	Ka	14.57	0.986	1.620	wt.%	
Si	Ka	17.55	1.082	1.492	wt.%	
S	Ka	57.13	1.952	3.251	wt.%	
Cl	Ka	14.26	0.975	0.784	wt.%	
Mn	Ka	4.22	0.531	0.315	wt.%	
Fe	Ka	755.60	7.097	92.538	wt.%	
				100.000	wt.%	Total

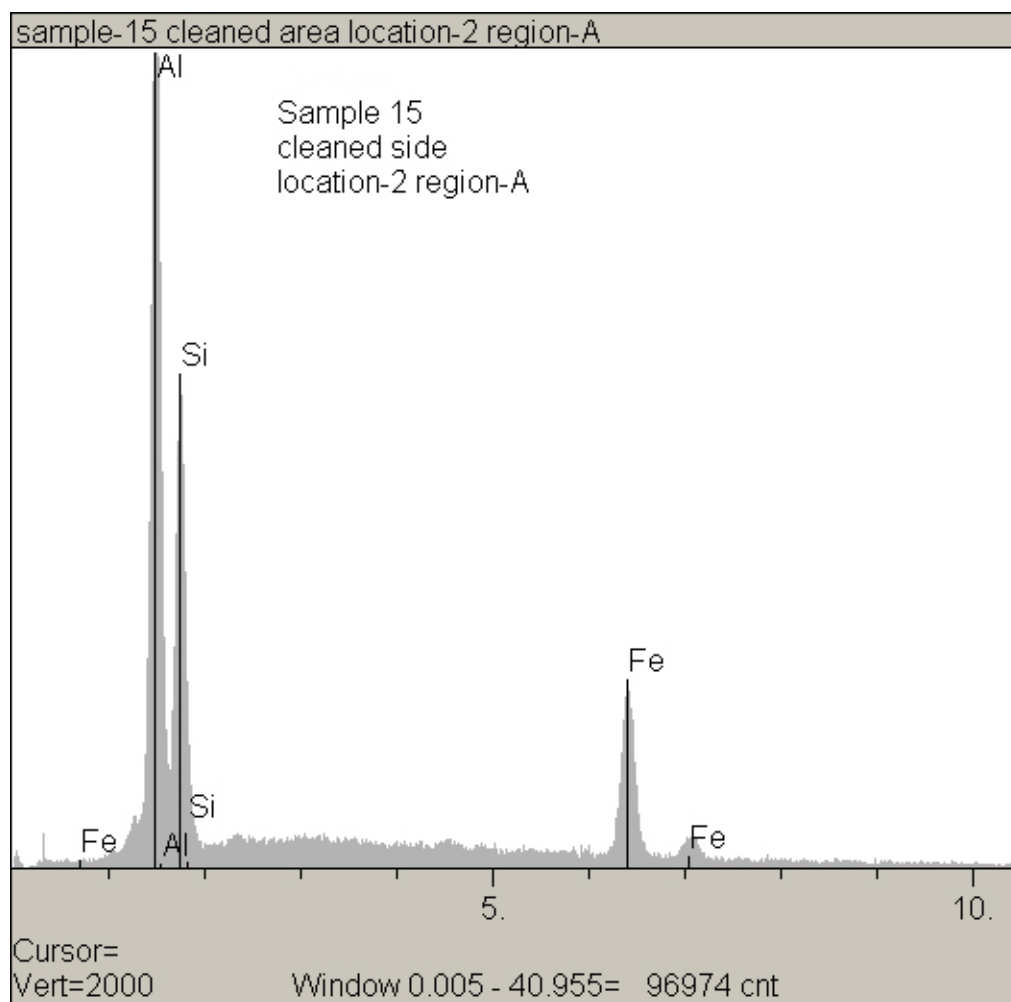
Sample #2, EDS Report, Field C, Region A

Elt.	Line	Intensity (c/s)	Error 2-sig	Conc	Units	
Al	Ka	461.70	5.548	39.720	wt.%	
Si	Ka	236.35	3.969	34.473	wt.%	
Fe	Ka	115.43	2.774	25.807	wt.%	
				100.000	wt.%	Total
